NACA RM SA54109

AN INVESTIGATION IN THE AMES 40- BY 80-FOOT WIND TUNNEL OF

A YT-56A TURBOPROP ENGINE INCORPORATING A DECOUPLER

AND A CONTROLLED-FEATHERING DEVICE

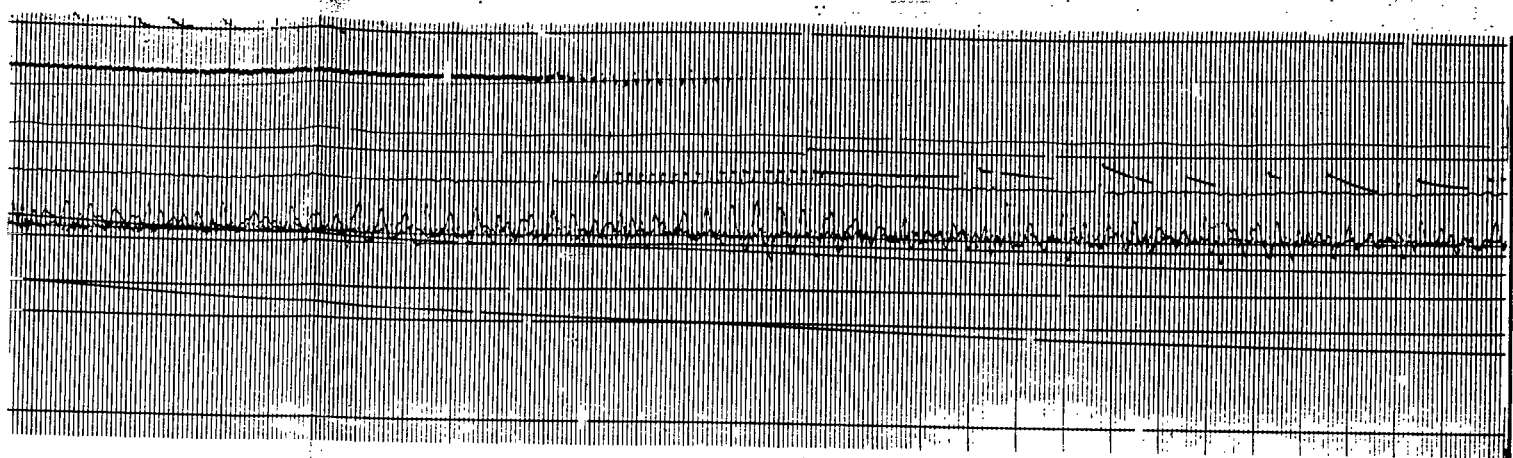
Figure 6.- Typical oscillograms for simulated power failure; airspeed = 230 mph, power-lever setting = full temperature (900° F). (a) Decoupler free to operate, no controlled-feathering device. (b) Controlled-feathering device, decoupler not free to operate.

ograms for simulated power failure ; airspeed = 230 mph, power-lever setting = f
